Re: MME Project # 13511

Metals and Materials Engineers, LLC (MME) was retained by Mr. Dean Hettenbach of Composite Materials Technology, LLC to conduct flammability testing on a composite pole. MME's scope of analysis included flammability testing and subsequent visual examination.

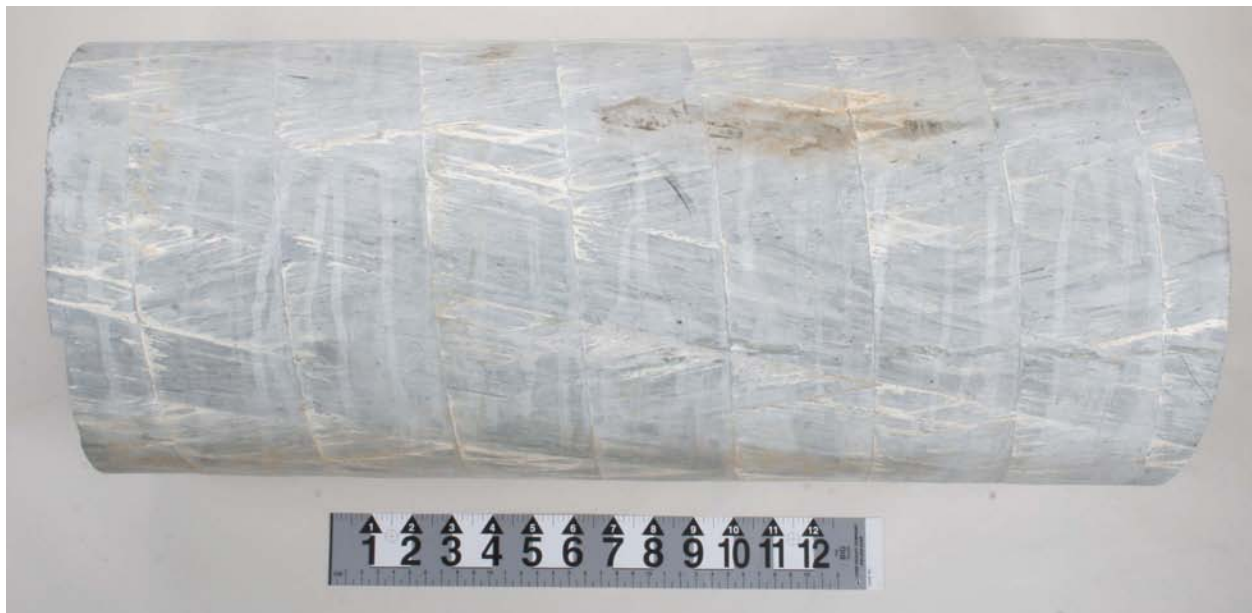
Figure 1. Composite pole in the as-received condition

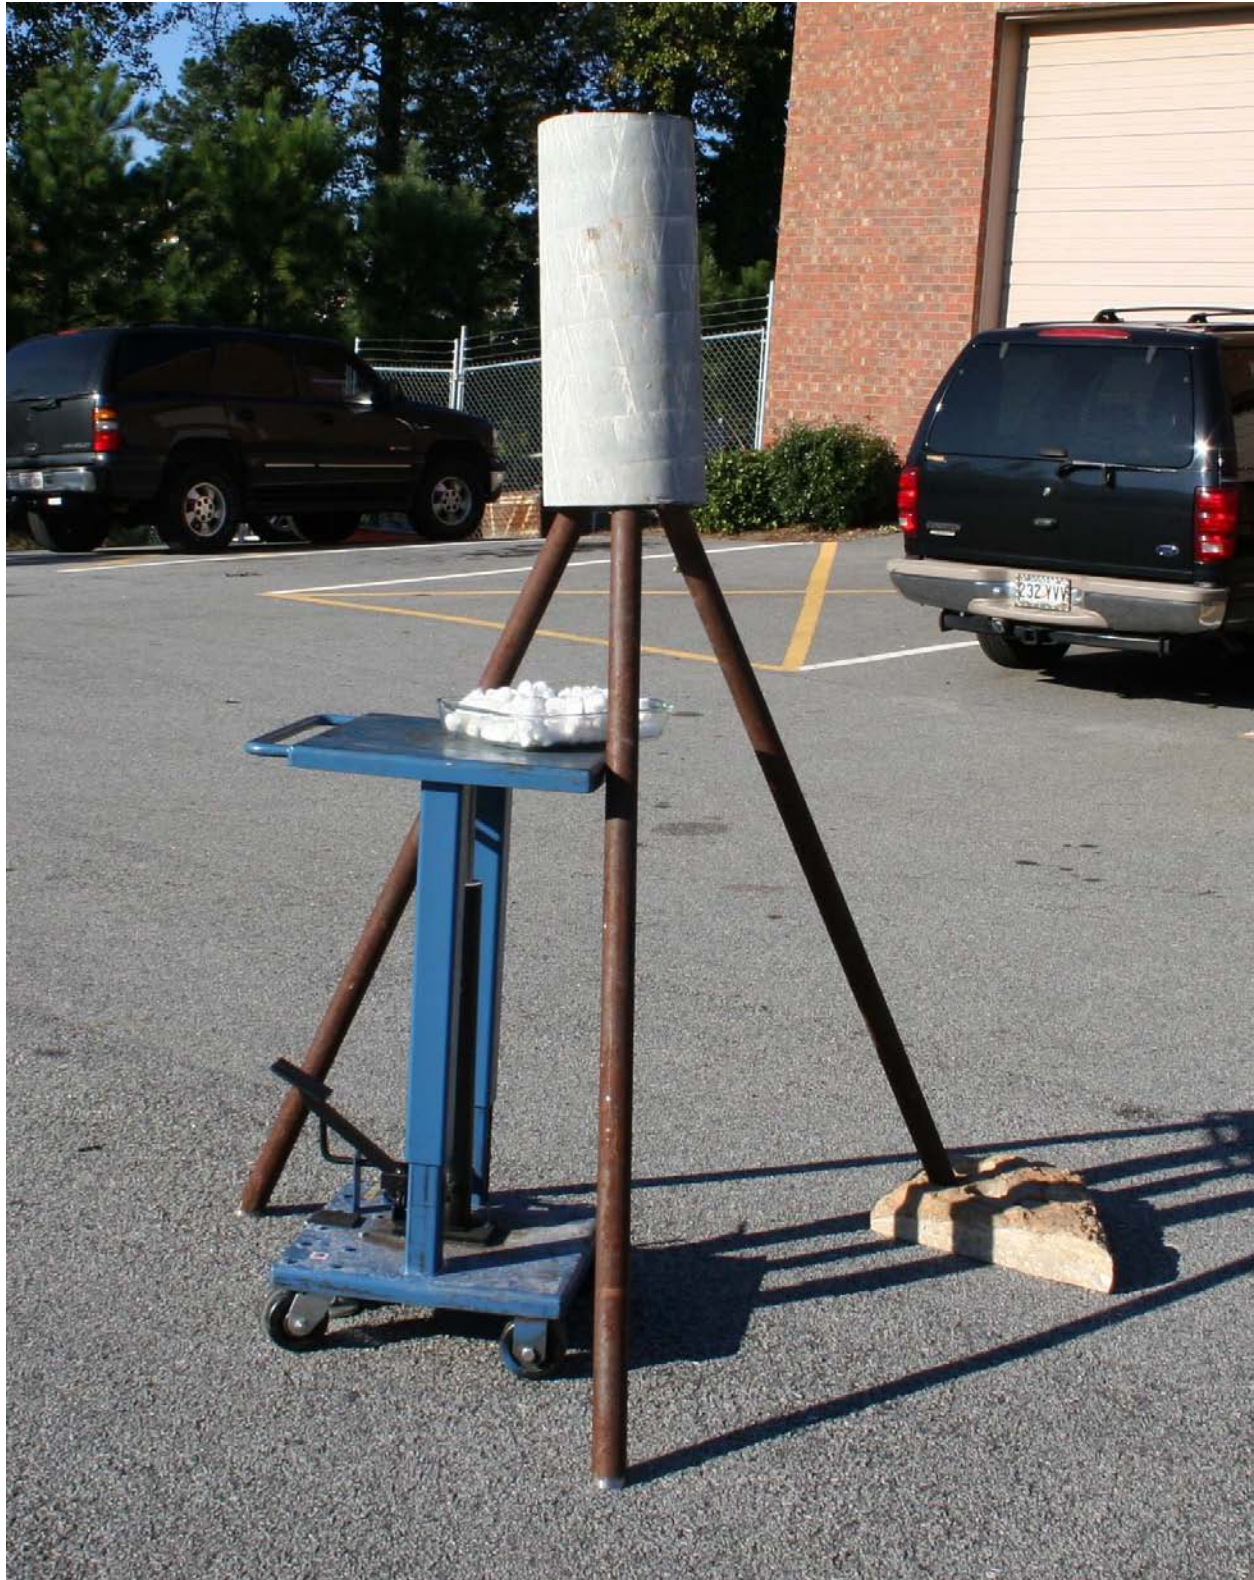
Figure 2. Photograph of testing apparatus

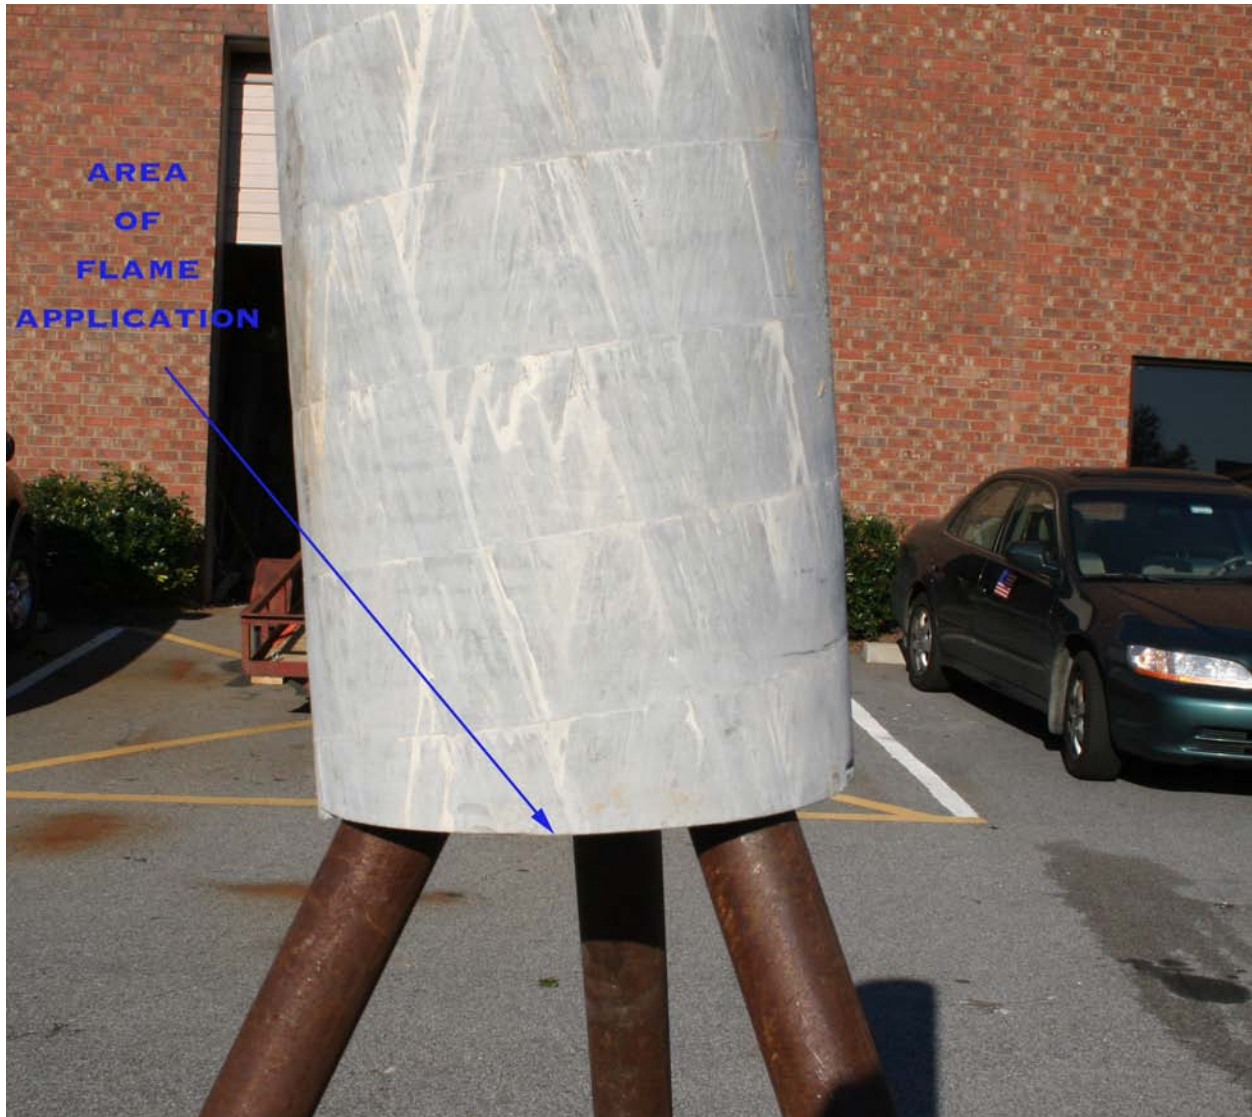
The pole was removed from the apparatus after the second burn in order to further examine the thermally tested area. As stated previously, the pole did not display any significant signs of thermal damage. Comparing the results to the UL 94 specification, the pole performed within the most stringent specified limits for a vertical burn test. Upon removal of the pole it was observed that a significant amount of thermal energy had been absorbed by the pole, making it and warm to the touch. After performing the vertical burn test described, it is apparent that the composite pole tested exhibited good resistance to flammability. The pole did not exhibit signs of significant burning, deformation, or discoloration.

Figure 3. Photograph illustrating the tested area

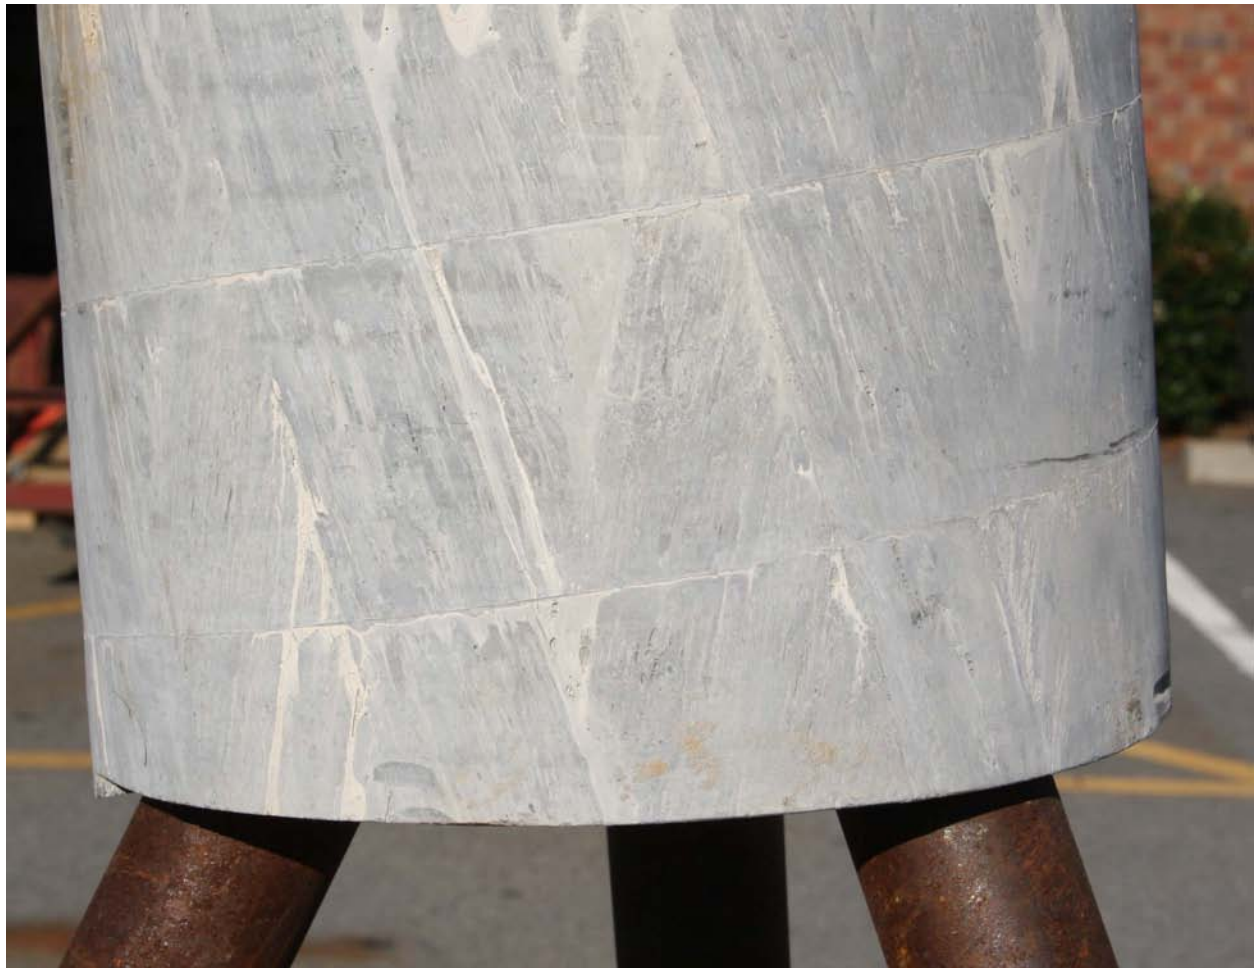
After the first burn, the pole exhibited no thermal deformation or discoloration and no flames were observed. The cotton beneath the tested area did not ignite, furthermore, there was no dripping of material nor flaming drips. A slight odor was detected directly following the burn, however, there were no visible gases. Similar observations were noted following the second burn.

Figure 4. Photograph of tested area directly after the first application of flame

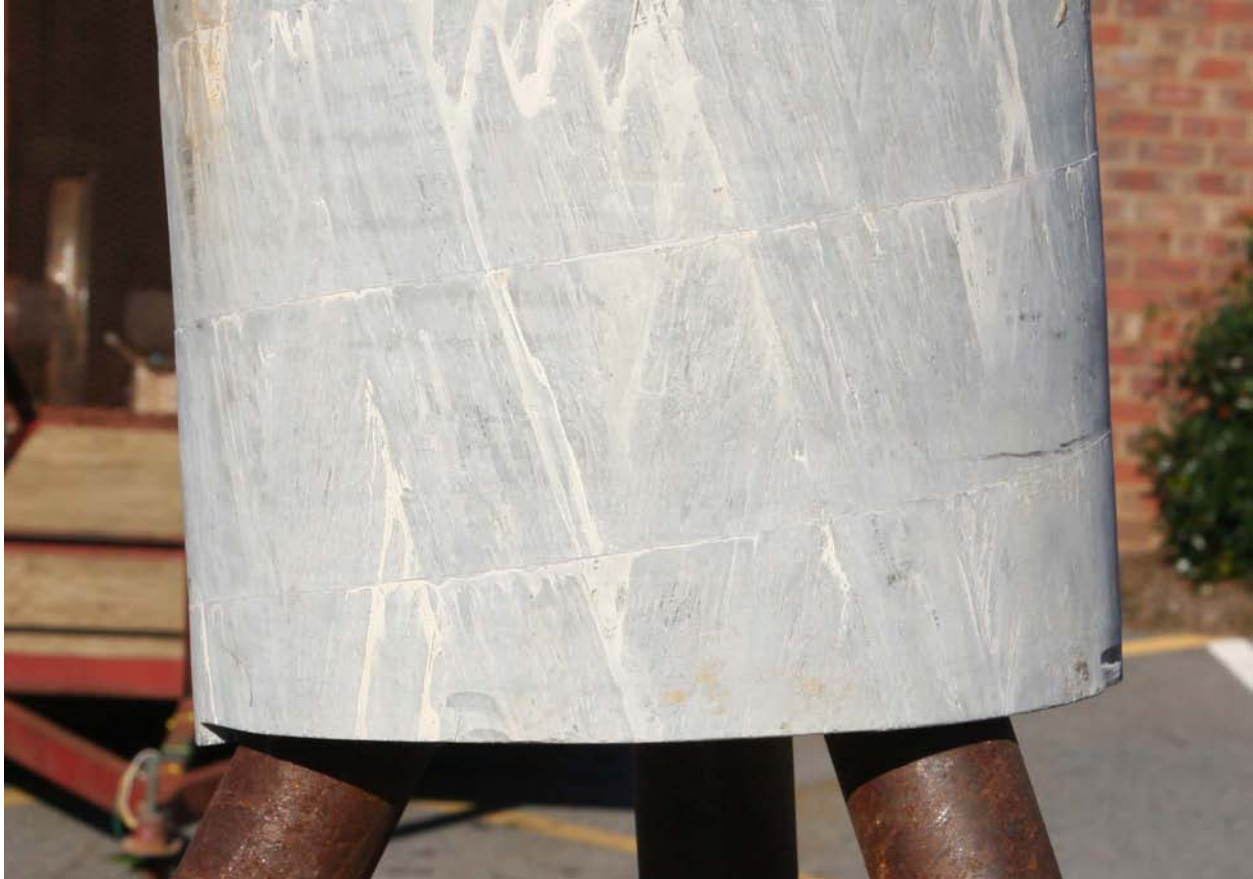
Figure 5. Photograph of tested area directly after the second application of flame
