**Testing of Polymer Concrete Composite Power Poles in
Accordance with the ENA Pole Fire Test Method**

CMT Eco-Titan Polymer Concrete Pole

Report # 10007

**Dulhunty Poles Pty Ltd,
Moolap, Victoria, Australia**

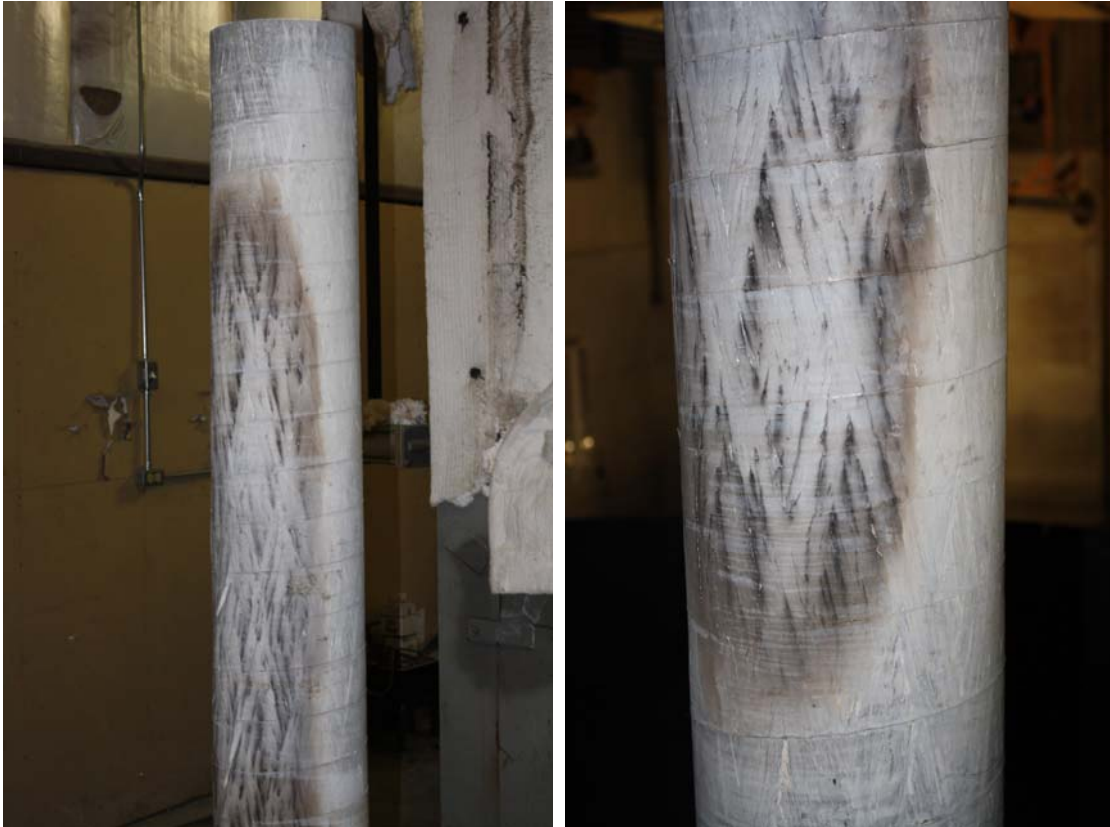
Test #1 (Pole Sample No.3)

Post-Exposure Observations: Upon relocation of the test pole to the post exposure examination area and prior to the 5 mph wind exposure, the maximum surface temperature was determined to be 186°C. The surface temperature diminished to 48°C after 35 minutes. The wind exposure was terminated at 70 minutes, with the surface temperature between 20-30°C. No signs of combustion were noted upon termination of the fire exposure. The exposed surface of the test pole section exhibited surface cracking and delamination of the top 2-3 layers of the pole surface. Surface disruption extended no further than approximately the first 3-4mm of the specimen thickness.

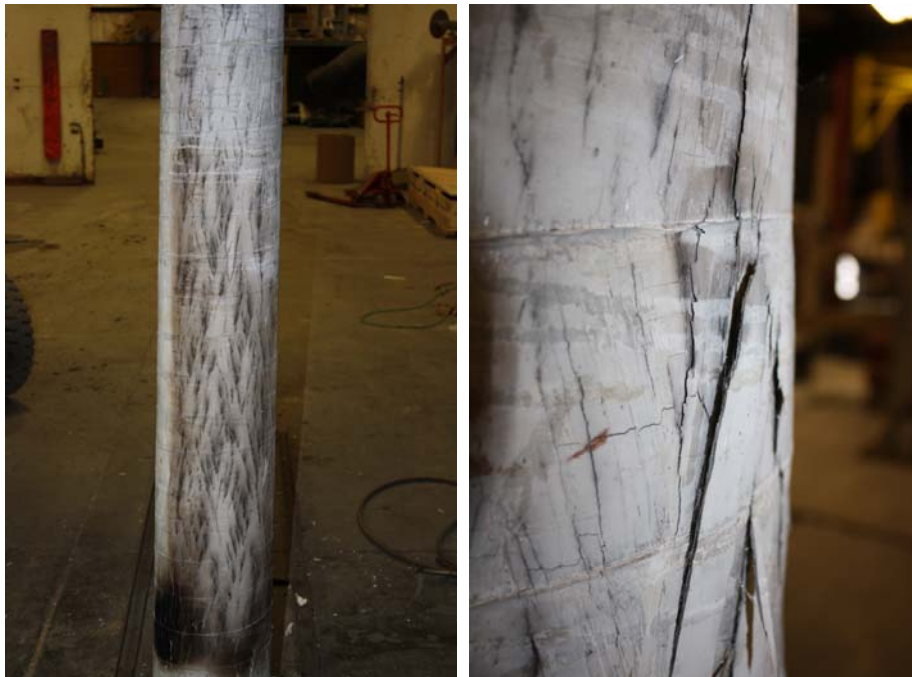
Test #2 (Pole Sample No. 1)

Post-Exposure Observations: Upon relocation of the test pole and prior to the 5 mph wind exposure, the maximum surface temperature was determined to be 130°C. The surface temperature diminished to 42°C after 38 minutes, whereupon the wind exposure was terminated. No signs of combustion were noted on the pole sample after termination of the fire test. The exposed surface of the test pole section exhibited surface cracking and delamination of top 2-3 layers of the pole surface. Surface disruption extended no further than approximately the first 3-4 mm of the specimen thickness.

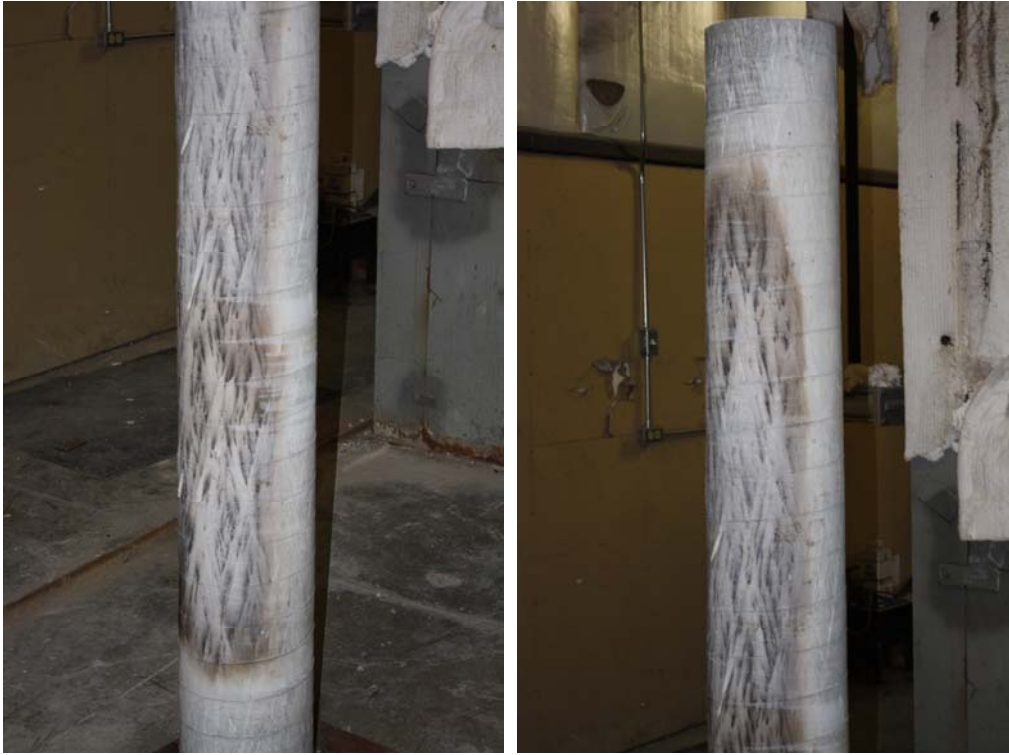
Immediately post-test
