Titan Newsletter

Overheard Lines from The Reliable Titan

Pole Strength Validity in Repeatable Manufacturing

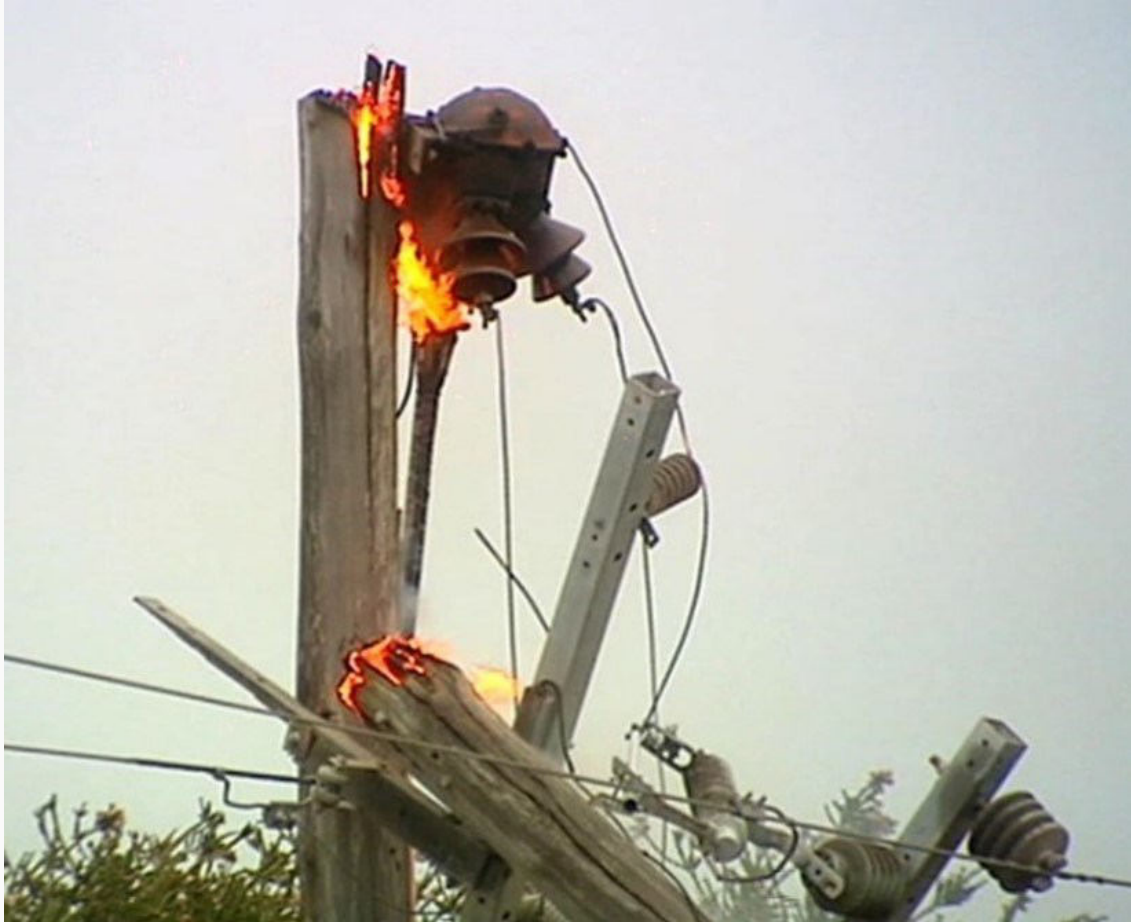
Whilst still on the subject of fires, history of the Australian ESI suggests pole top fires could happen to wood poles – either hardwood or softwood, at any time, given the right seasonal conditionals.

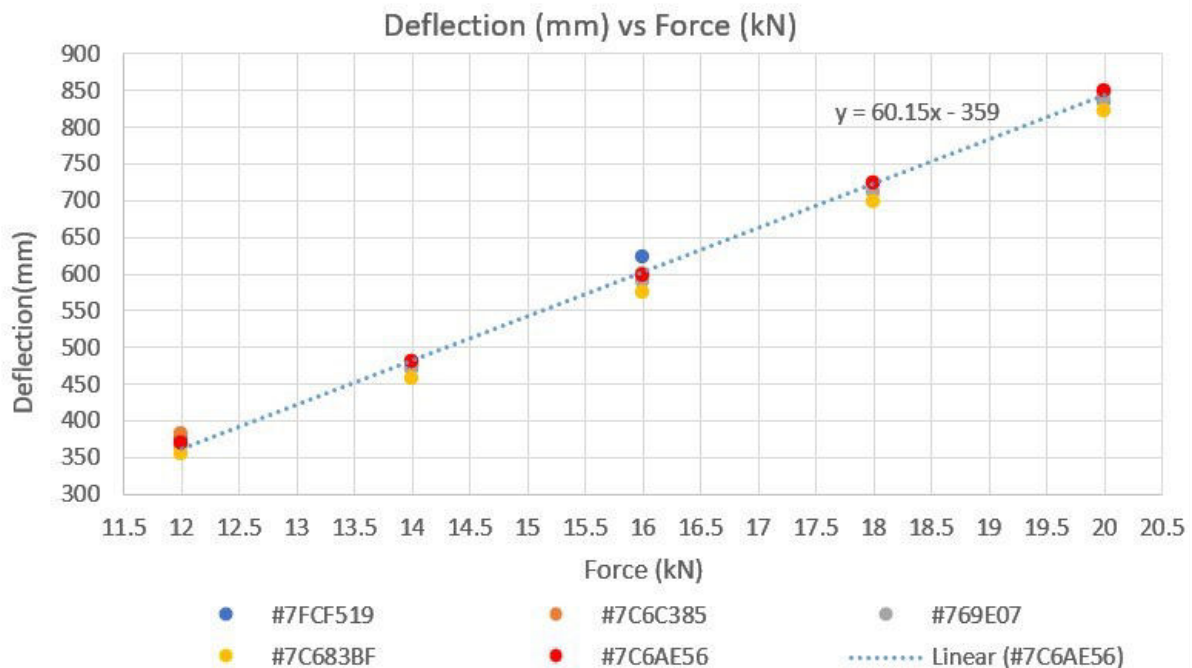
Figure 1.

The result in the figure 1 graph above utilises values from 12kN to the target load of 20kN highlighting a very repeatable and linear performance of the poles reflecting the manufacturing process and material matrix control. Additionally, the pole failure loads have not reduced and show no negative change up to 12 months old.

Pole failure occurred in range of 23kN – 27kN above ground line by normal mode of compression at the joint on the side facing the application of load as shown in test results table.

Moreover, the gradient of the line between 12kN - 20kN in both cases are very similar, meaning the rigidity has not shown any noticeable change.

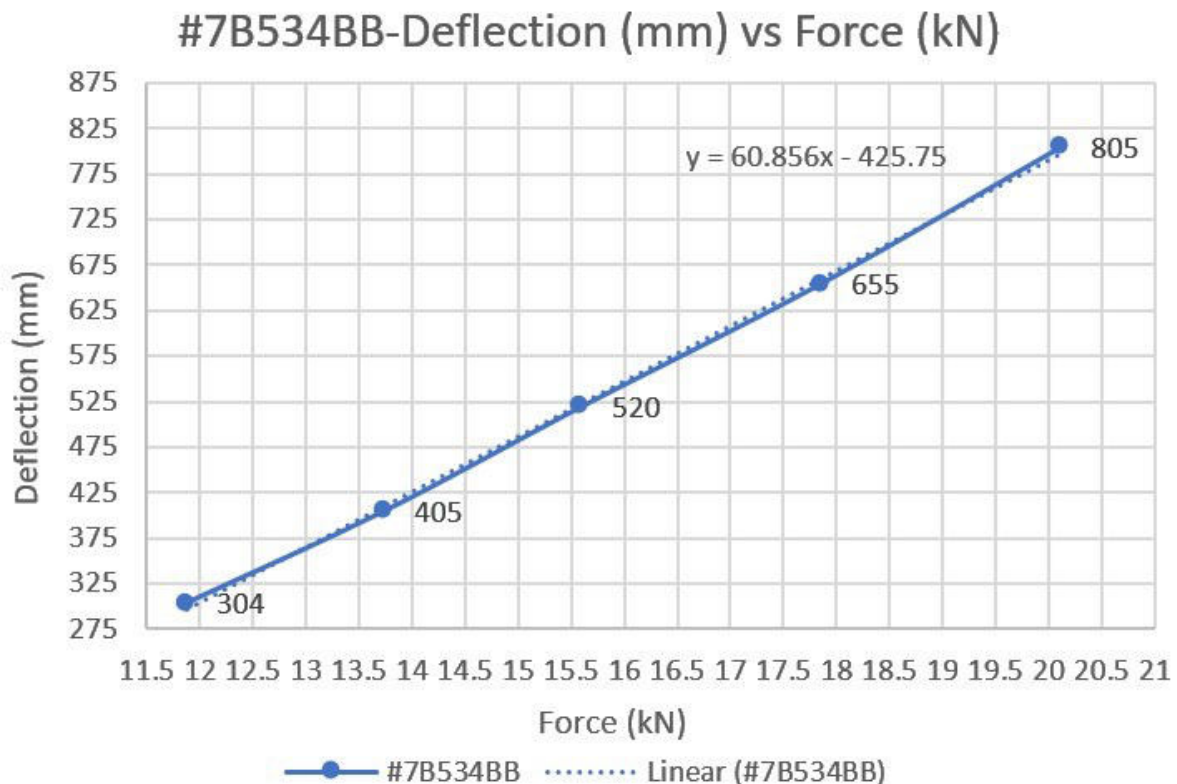
Figure 2.

Figure 2 graph above shows an earlier pole test of a Titan pole performed on 21/11/18 of the same design and construction, undertaken by an independent outside organisation. That pole was a younger pole being 50 days old and as shown in figure 2, no reduction in breaking load is evident.

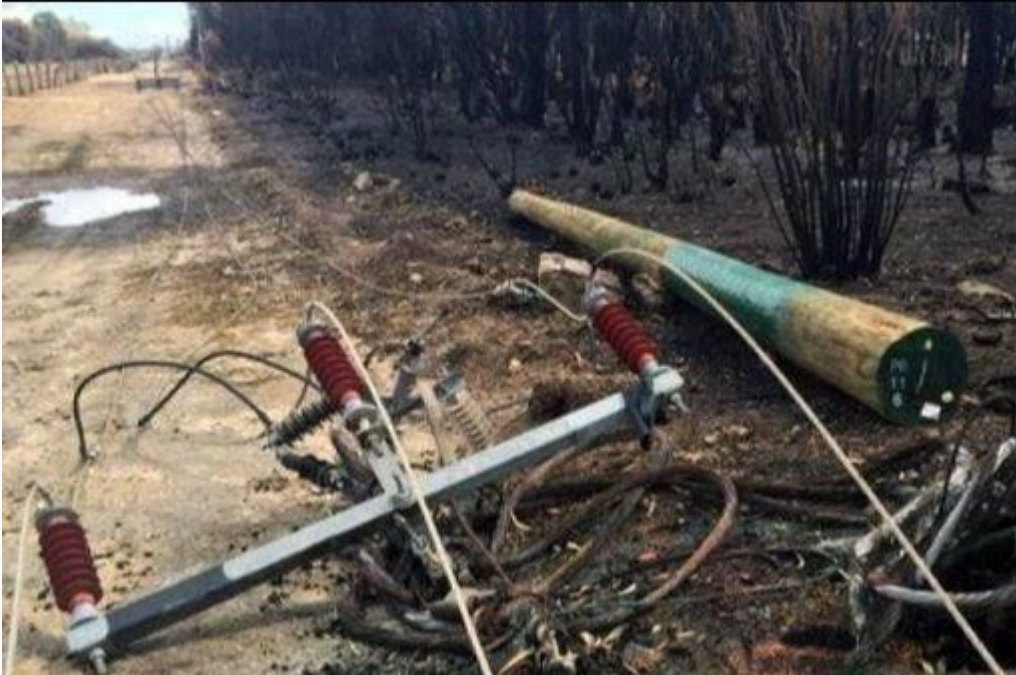
We are aware that we do use the below picture relatively regularly in our Titan Newsletters, mainly because it is a perfect example of the point we are attempting to make on this subject. The intention in this fire prone area depicted, appears to be to reintroduce this previous network failure-causing risk factor,

back into the network, by reinstalling another burnable pole, which is obviously supporting crucial high voltage operational equipment.

By providing just a bit more initial consideration and investment in the network through utilization of the resilient Titan, that massive expense and inconvenience attached to replacing that new non-bushfire proof pole is avoided – not just for one fire season, but for virtually a lifetime.

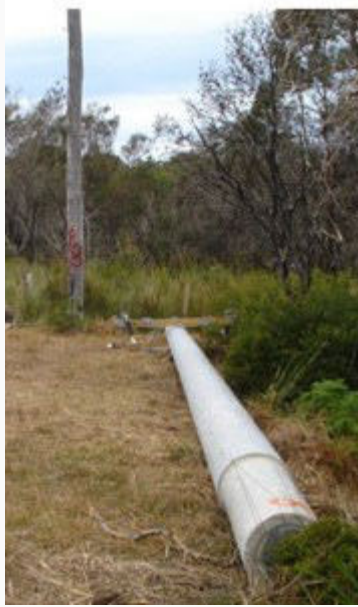
And an ever so simple, yet highly effective example above of the plan to build back better, with a replacement bushfire proof Titan ready to go – again in a fire prone area. It is understood replacement occurred the day after photo was taken. Job done – it is that simple.

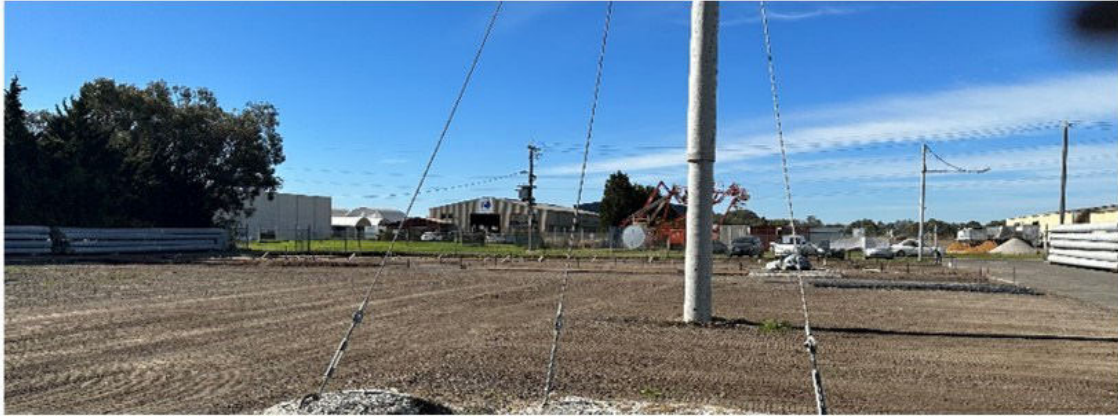
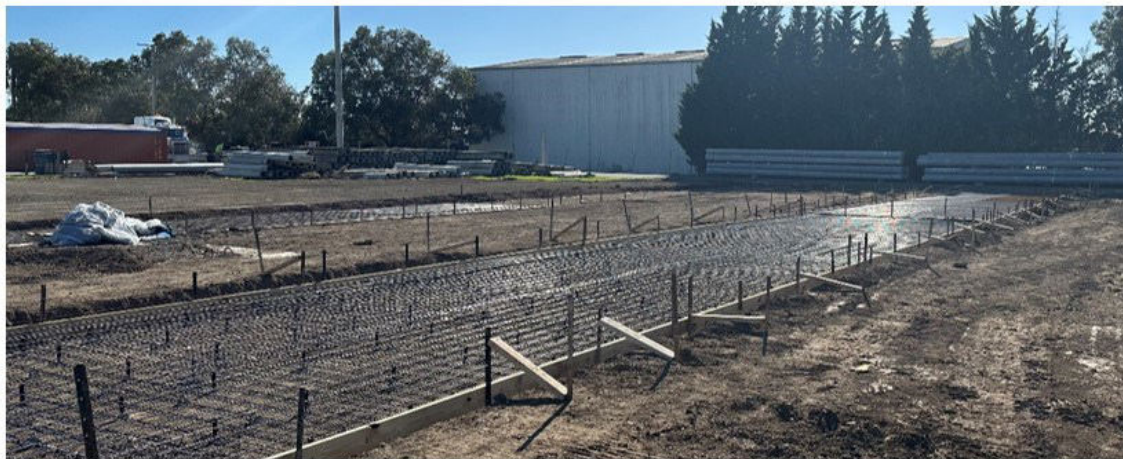
When demand for products keep growing, not only does the manufacturing of the product have to increase to meet the demand, but other important support functions also need to follow. Our Titan Pole storage / pole curing area is one such feature that has now had its turn to expand.

Progress photos of construction underway, with project completion well in sight

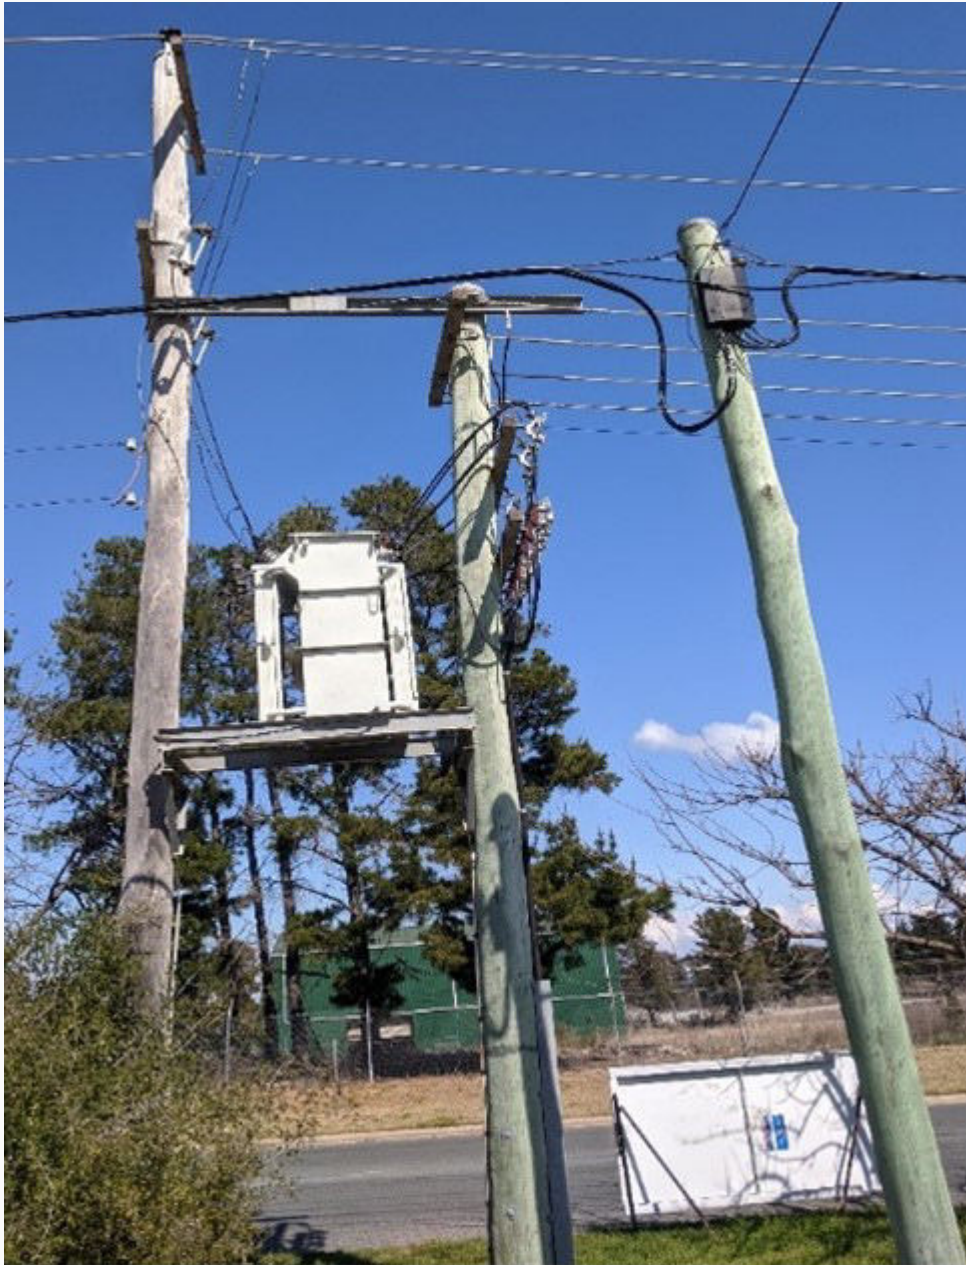
All this high maintenance, fundamental support infrastructure in the above picture, can be replaced with one no-maintenance engineered 'Equipment Grade' Titan Pole. The wood pole groundline inspection and treatment for this 3-pole existent installation is reduced to zero with one Titan.
